BMW 3: 1GXH118			
Vinnumber:	WBA3K11050F832990	Versionname:	3 TOURING 318d 143PK
First Registrationdate:	26/05/2014	Fiscalpower:	
Expertise Mileage:	184672	Power Kw:	105
Bodytype:	Break	Body color:	Dark Blue
Gearbox:	MAN 6 VIT	Paint type:	Metalic
Transmission:		Rims summer:	Aluminium
Fueltype:	Diesel	Oil level:	OK
Battery functioning:	Yes		
Number of doors:	5		
Number of seats:	5		
Number head rests:	5		
Rims summer:	Aluminium		
Category:	Passenger Car		
Oil level:	OK		
Registration Certificate Car (BE):	Yes

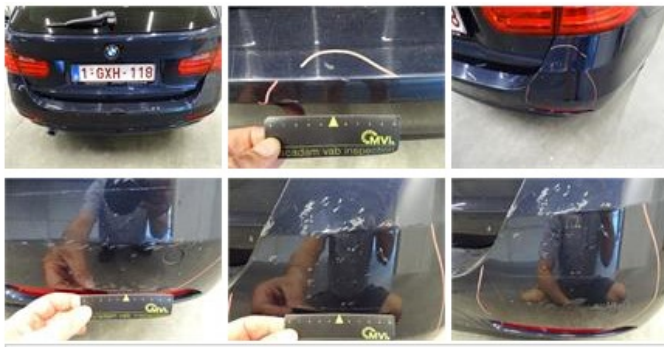
Assistance equipment			
Repair kit	Yes	Compressor	Yes
Total cost ex VAT			306,80
Door F L, Scratch(es), Acceptable			0,00
<i>No pictures to display</i>			
Bumper R, Scratch(es), LI - Repair and paint (complete)			211,80
