**LU Audi q3: HU0918**

**Limited Technical Inspection**

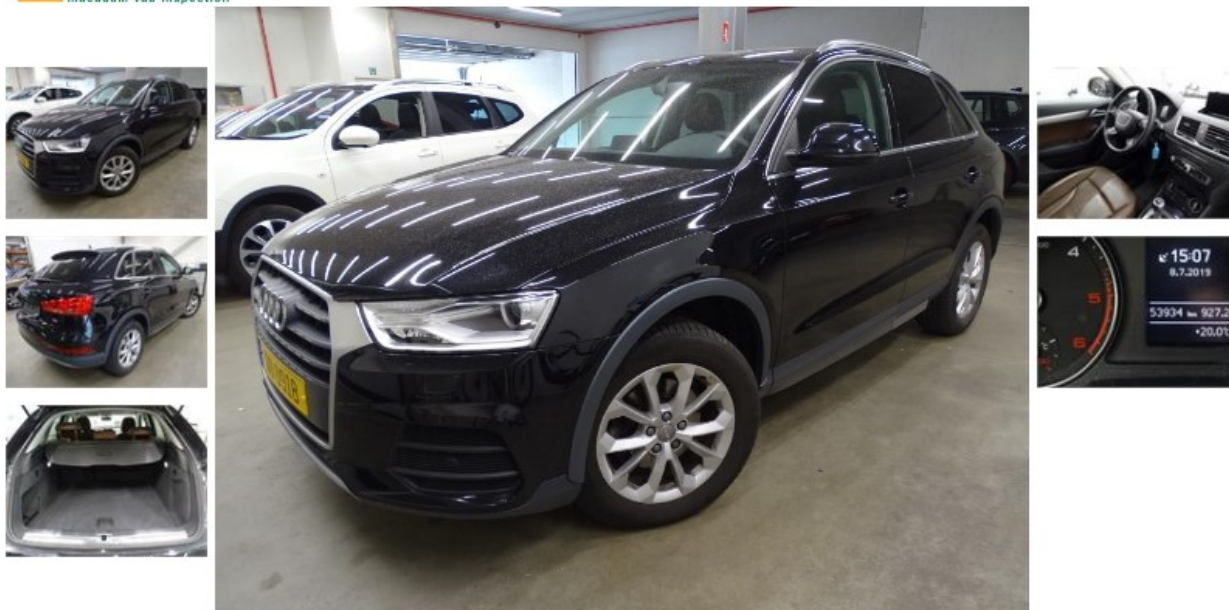
Total cost ex VAT	786,70
Ignition key, Missing, E - Replace	150,00
<i>No pictures to display</i>	
Door F R, Dent(s) and scratch(es), LI - Repair and paint (complete)	318,35
