**RENAULT Kangoo Express: 1FWU501**

**Limited Technical Inspection**

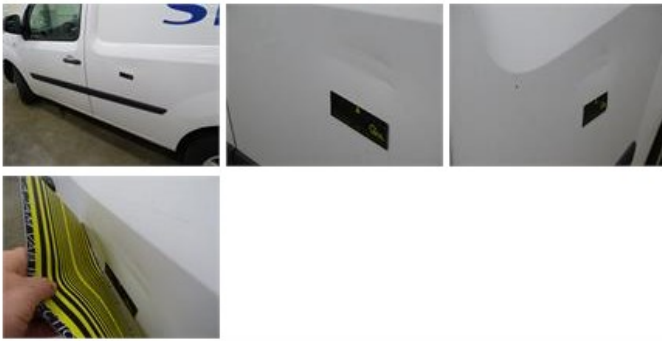
Total cost ex VAT	646,71
Bodywork, Not original part, Acceptable	0,00
<i>No pictures to display</i>	
Wing R L, Dent(s) and scratch(es), LI - Repair and paint (complete)	231,15

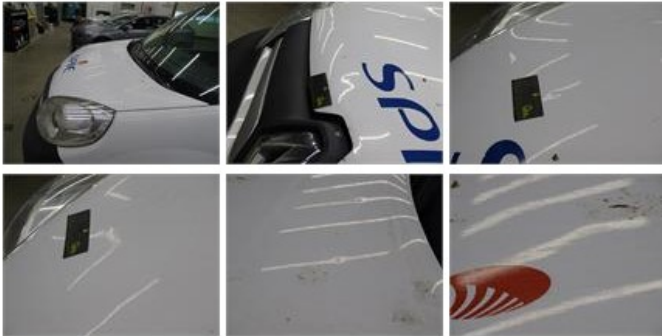
Door F R, Scratch(es), Acceptable	0,00
<i>No pictures to display</i>	
Bonnet, Dent(s), LI - Repair and paint (complete)	361,56
