BMW 3 TOURING: 1KXU348

Vinnumber:	WBA8L51040K585978	Versionname:	2.0 316D (85KW) TOURING
First Registrationdate:	28/07/2015	Fiscalpower:	
Expertise Mileage:	70649	Power Kw:	85
Bodytype:		Body color:	Black
Gearbox:	Automatic	Paint type:	Metallic
Transmission:	Back	Rims summer:	Aluminium
Fueltype:	Diesel	Oil level:	OK
Maintenance:	OK	Parking lot:	4515
Maintenance:	OVER 20000KM		
Battery functioning:	Yes		
Number of doors:	5		
Number of seats:	5		
Number head rests:	5		
Rims summer:	Aluminium		
Category:	Passenger Car		
Oil level:	OK		
Registration Certificate Car (BE):	Yes

Limited Technical Inspection

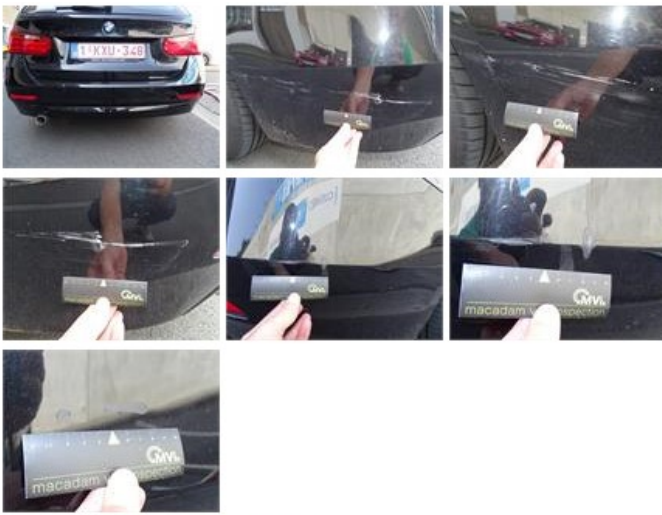
Repair kit	Yes	Compressor	Yes
Total cost ex VAT			577,36
Bumper R, Scratch(es), LI - Repair and paint (complete)			211,80

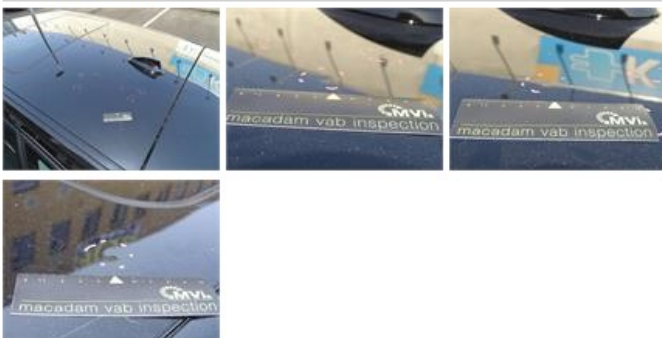
Roof, Hail damage, PDR - Hail 250,00
