**BMW 4 GRAN COUPE: 1LGF448**

Vinnumber:	<b>WBA4E91000G287284</b>	Versionname:	<b>2.0 420D (120KW) GRAN COUPE</b>
First Registrationdate:	<b>21/09/2015</b>	Fiscalpower:	
Expertise Mileage:	<b>131662</b>	Power Kw:	<b>120</b>
Bodytype:		Body color:	<b>Grey</b>
Gearbox:	<b>Automatic</b>	Paint type:	<b>Metalic</b>
Transmission:	<b>Back</b>	Rims summer:	<b>Aluminium</b>
Fueltype:	<b>Diesel</b>	Oil level:	<b>OK</b>
Battery functioning:	<b>Yes</b>	Parking lot:	<b>4603</b>
Number of doors:	<b>5</b>		
Number of seats:	<b>5</b>		
Number head rests:	<b>5</b>		
Rims summer:	<b>Aluminium</b>		
Category:	<b>Passenger Car</b>		
Oil level:	<b>OK</b>		
Registration Certificate Car (BE):	<b>Yes</b>

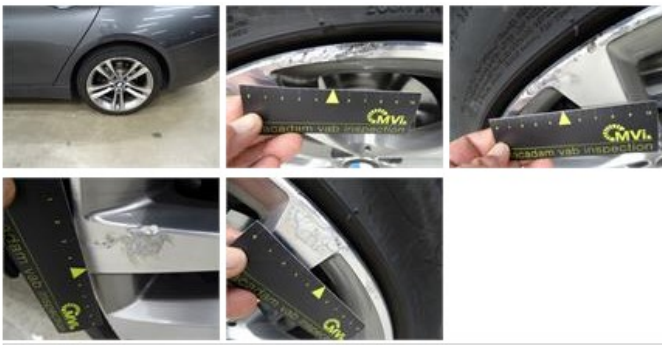
Total cost ex VAT	996,18
Door R R, Scratch(es), Acceptable	0,00
<i>No pictures to display</i>	
Alloy rim R L polished, Scratch(es), LI - Repair and paint (complete)	95,00

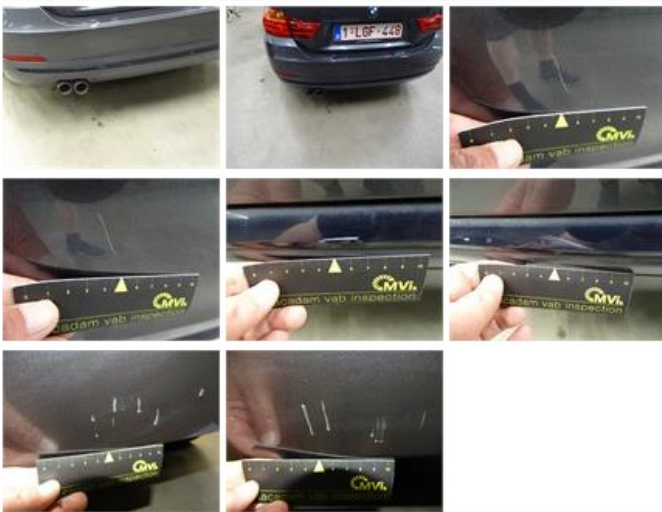
Bumper R, Scratch(es), LI - Repair and paint (complete) 254,16
