**MINI : 1KNN193**

**Limited Technical Inspection**

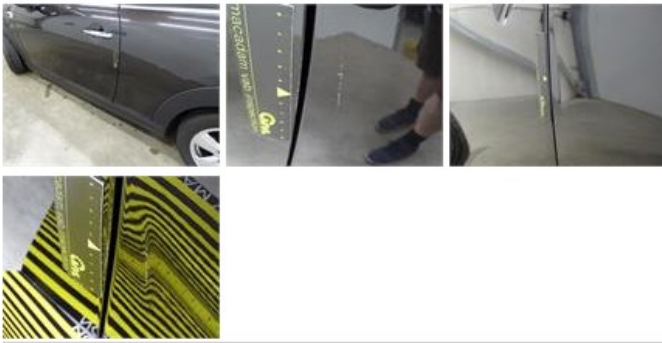
Total cost ex VAT	1079,78
Windscreen, Stone chip(s), Acceptable	0,00
<i>No pictures to display</i>	
Wing R L, Dent(s) and scratch(es), LI - Repair and paint (complete)	308,20
