**BMW 4 GRAN COUPE: 1KUE972**

**Limited Technical Inspection**

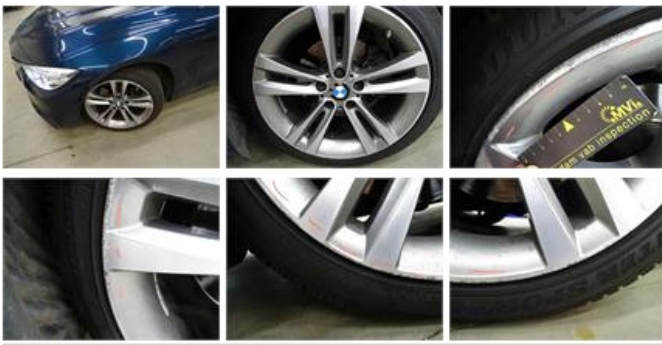
Total cost ex VAT	996,18
Alloy rim F L polished, Scratch(es), LI - Repair and paint (complete)	95,00

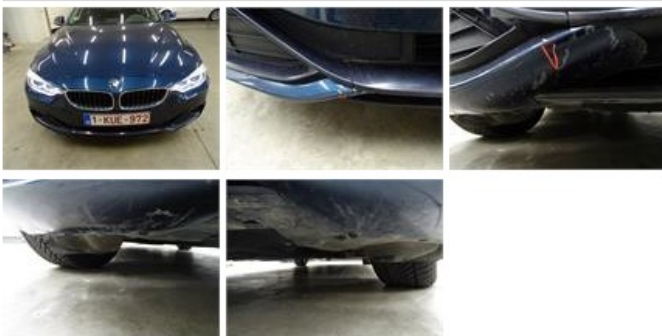
Bumper F, Scratch(es), LI - Repair and paint (complete)	254,16
---	--------
