**AUDI A4: 1KPK333**

**Limited Technical Inspection**

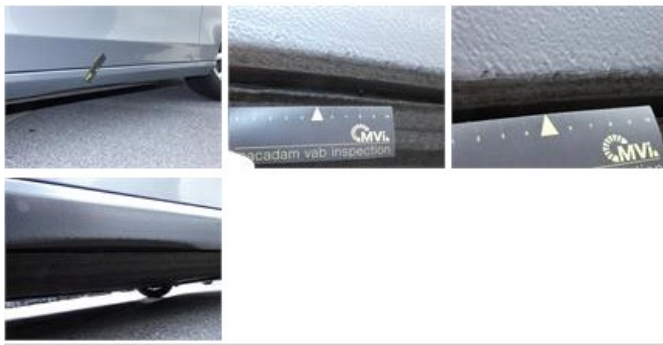
Sill outer R, Dent(s) and scratch(es), LI - Repair and paint (complete)	406,50
---	--------
