**FORD FIESTA: 1UH2540**

**Limited Technical Inspection**

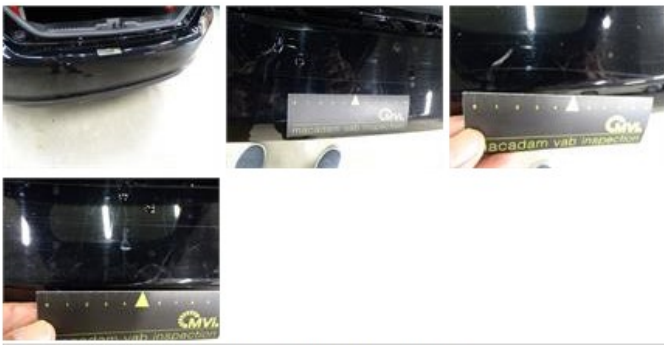
<b>Total cost ex VAT</b>	<b>530,15</b>
Door R R, Scratch(es), Acceptable	0,00
<i>No pictures to display</i>	
Wing F L, Scratch(es), Acceptable	0,00
<i>No pictures to display</i>	
Bonnet, Scratch(es), Acceptable	0,00
<i>No pictures to display</i>	
Bumper R, Scratch(es), LI - Repair and paint (complete)	211,80
