VOLKSWAGEN Golf: 1HKV415

Limited Technical Inspection

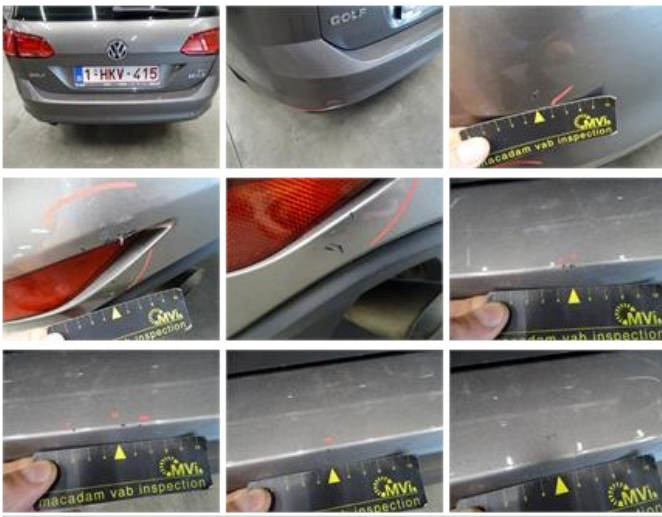
Total cost ex VAT	520,00
Door F L, Scratch(es), Acceptable	0,00
<i>No pictures to display</i>	
Bumper R, Dent(s) and scratch(es), LI - Repair and paint (complete)	211,80
