BMW 3 GRAN TURISMO: 1KSC925

Vinnumber:	WBA3Y11060GD87722	Versionname:	2.0 318D (100KW) GRAN TURISMO
First Registrationdate:	22/06/2015	Fiscalpower:	
Expertise Mileage:	171767	Power Kw:	100
Bodytype:		Body color:	Grey
Gearbox:	MAN 6 VIT	Paint type:	Metalic
Transmission:		Rims summer:	Aluminium
Fueltype:	Diesel	Oil level:	OK
Battery functioning:	Yes	Parking lot:	1726
Number of doors:	5		
Number of seats:	5		
Number head rests:	5		
Rims summer:	Aluminium		
Category:	Passenger Car		
Oil level:	OK		
Registration Certificate Car (BE):	Yes

Limited Technical Inspection

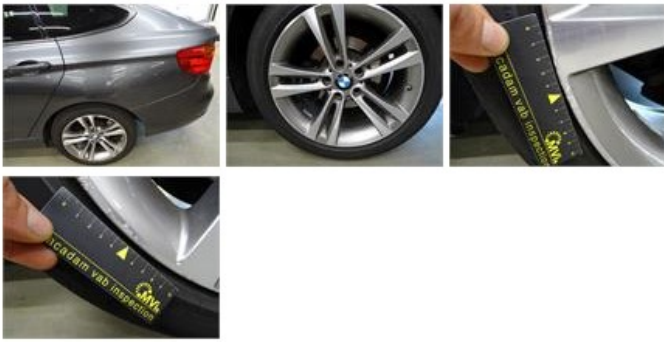
Runflat	Yes
Total cost ex VAT		95,00
Alloy rim F L polished, Rust, Acceptable		0,00
<i>No pictures to display</i>		
Bonnet, Stone chip(s), Acceptable		0,00
<i>No pictures to display</i>		
Alloy rim R L polished, Scratch(es), LI - Repair and paint (complete)		95,00
