BMW 2 ACTIVE TOURER: 1LKX537

Limited Technical Inspection

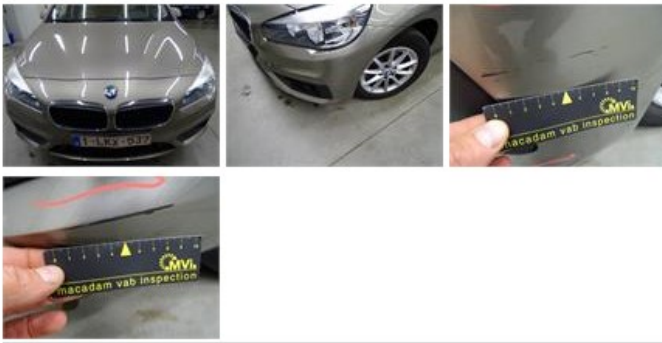
Bumper F, Scratch(es), LI - Repair and paint (complete)	211,80
---------------------------------------------------------	---------------
