**VOLVO V40: 1LDS636**

**Limited Technical Inspection**

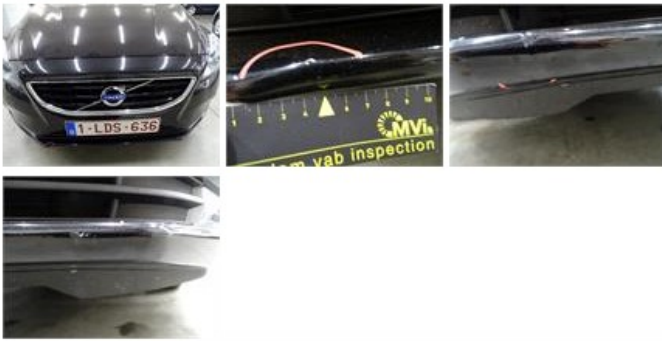
Total cost ex VAT	306,80
Alloy rim R L, Scratch(es), Acceptable	0,00
<i>No pictures to display</i>	
Bumper F, Dent(s) and scratch(es), LI - Repair and paint (complete)	211,80

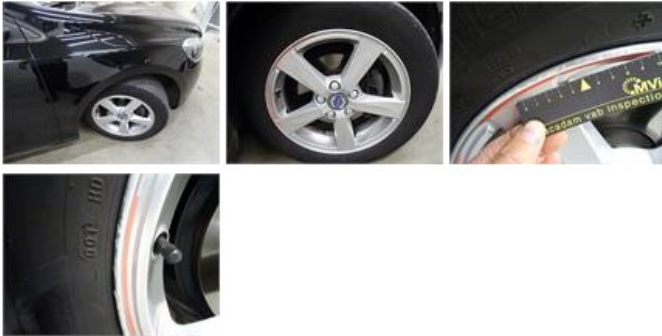
Alloy rim F L, Scratch(es), Acceptable	0,00
<i>No pictures to display</i>	
Bonnet, Stone chip(s), Acceptable	0,00
<i>No pictures to display</i>	
Alloy rim F R, Scratch(es), LI - Repair and paint (complete)	95,00
