AUDI A6: 1HSF882

Limited Technical Inspection

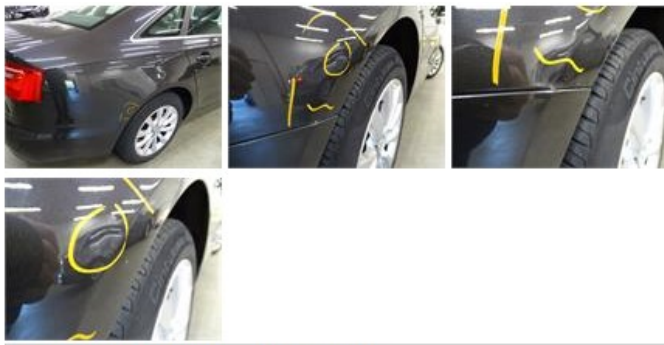
Repair kit	Yes	Compressor	Yes
Total cost ex VAT			1299,02
Wing R R, Dent(s) and scratch(es), LI - Repair and paint (complete)			369,84

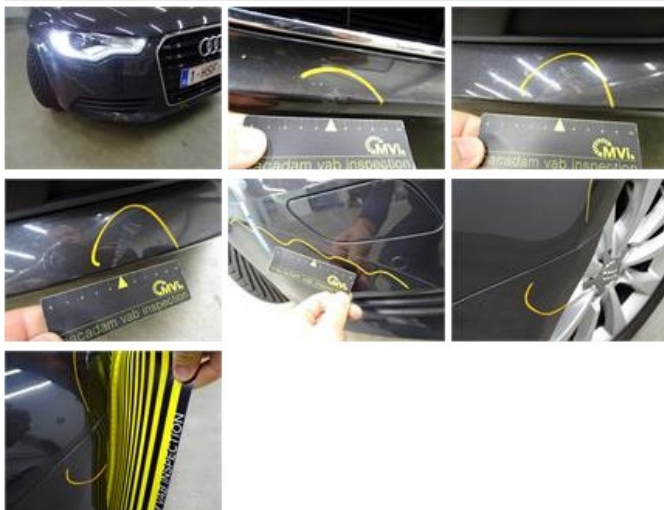
Bumper F, Dent(s) and scratch(es), LI - Repair and paint (complete) 254,16
