BMW 3: 1HTD725

Limited Technical Inspection

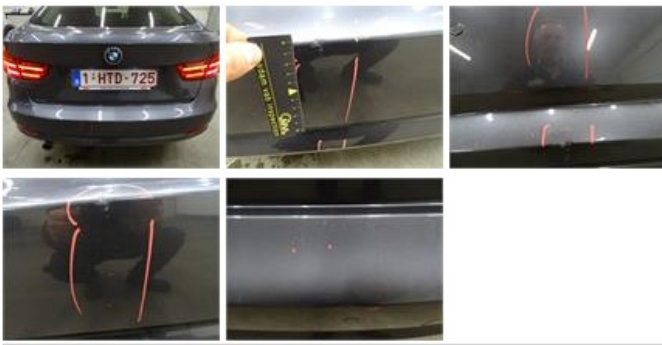
Repair kit	Yes	Compressor	Yes
Total cost ex VAT			423,60
Bumper R, Dent(s) and scratch(es), LI - Repair and paint (complete)			211,80
