PEUGEOT 308 SW: 1JTL119

Limited Technical Inspection

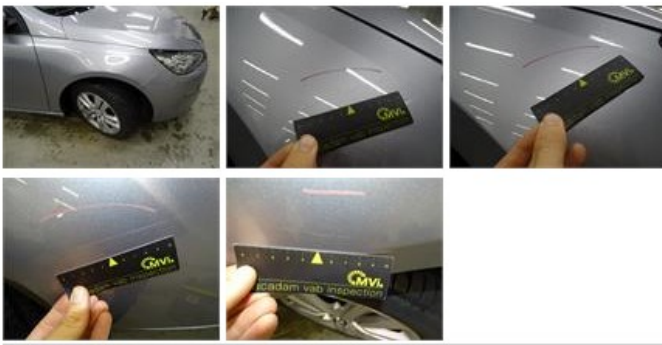
Total cost ex VAT	701,68
Door R R, Scratch(es), Acceptable	0,00
<i>No pictures to display</i>	
Wing F R, Scratch(es), LI - Repair and paint (complete)	220,18

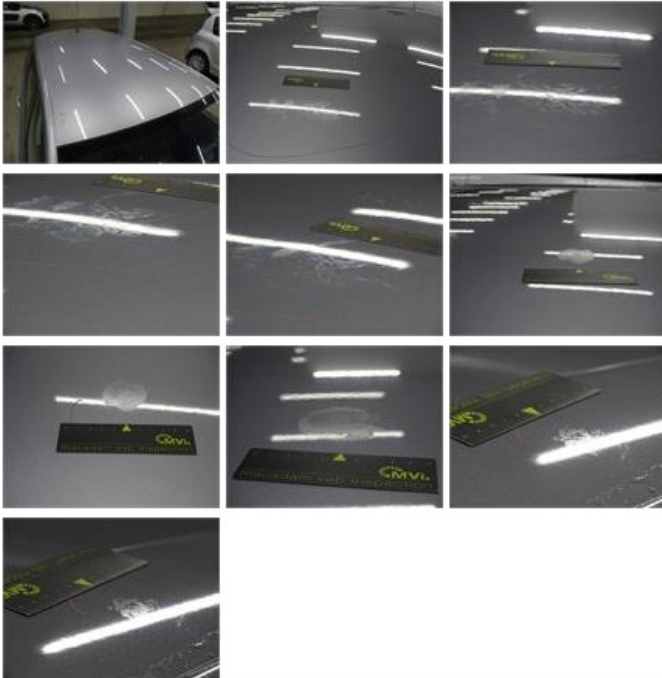
Roof, Chemical polution, LI - Repair and paint (complete) 481,50
