NISSAN Qashqai: 1HTP587

Limited Technical Inspection

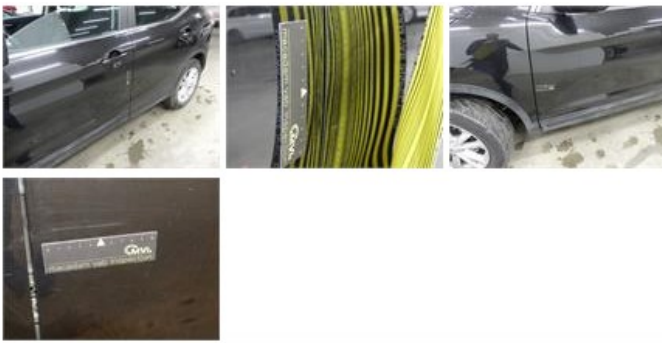
Emergency spare wheel	Yes	Jack	Yes
Total cost ex VAT			964,55
Wing F R, Scratch(es), Acceptable			0,00
<i>No pictures to display</i>			
Door F L, Dent(s) and scratch(es), LI - Repair and paint (complete)			318,35

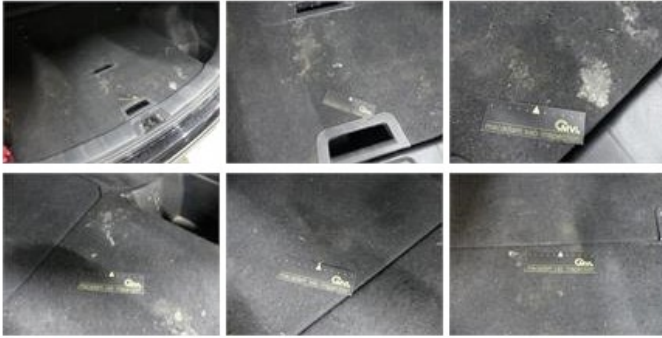
Wing R R, Dent(s) and scratch(es), Acceptable	0,00
<i>No pictures to display</i>	
Door R R, Dent(s) and scratch(es), Acceptable	0,00
<i>No pictures to display</i>	
Rearview mirror housing R, Scratch(es), Acceptable	0,00
<i>No pictures to display</i>	
Boot carpet, Chemical polution, E - Replace	100,00
