VOLVO V60: 1LPA183

Limited Technical Inspection

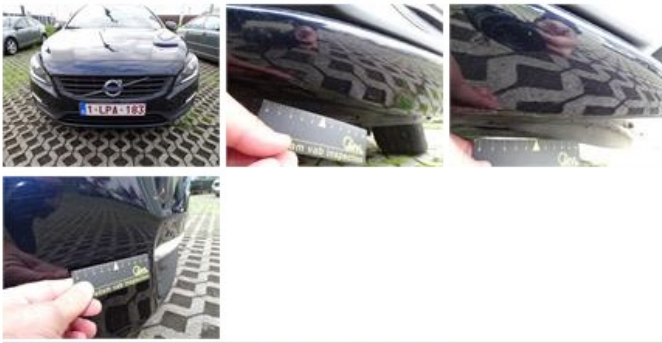
Bumper F, Scratch(es), LI - Repair and paint (complete)		211,80
---------------------------------------------------------	--	--------

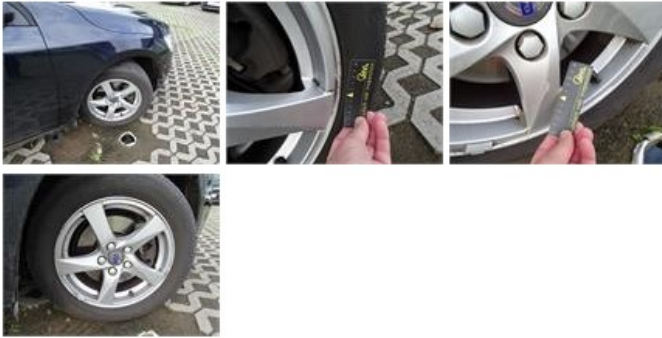
Alloy rim F R, Scratch(es), LI - Repair and paint (complete)	95,00
--------------------------------------------------------------	-------
