BMW 3 GRAN TURISMO: 1LLZ298

Vinnumber:	WBA3Y11030GD87774	Versionname:	2.0 318D (100KW) GRAN TURISMO
First Registrationdate:	23/10/2015	Fiscalpower:	
Expertise Mileage:	157595	Power Kw:	100
Bodytype:		Body color:	Black
Gearbox:	MAN 6 VIT	Paint type:	Metallic
Transmission:	Back	Rims summer:	Aluminium
Fueltype:	Diesel	Oil level:	OK
Maintenance:	OK	Parking lot:	4301
Battery functioning:	Yes		
Number of doors:	5		
Number of seats:	5		
Number head rests:	5		
Rims summer:	Aluminium		
Category:	Passenger Car		
Oil level:	OK		
Registration Certificate Car (BE):	Yes

Limited Technical Inspection

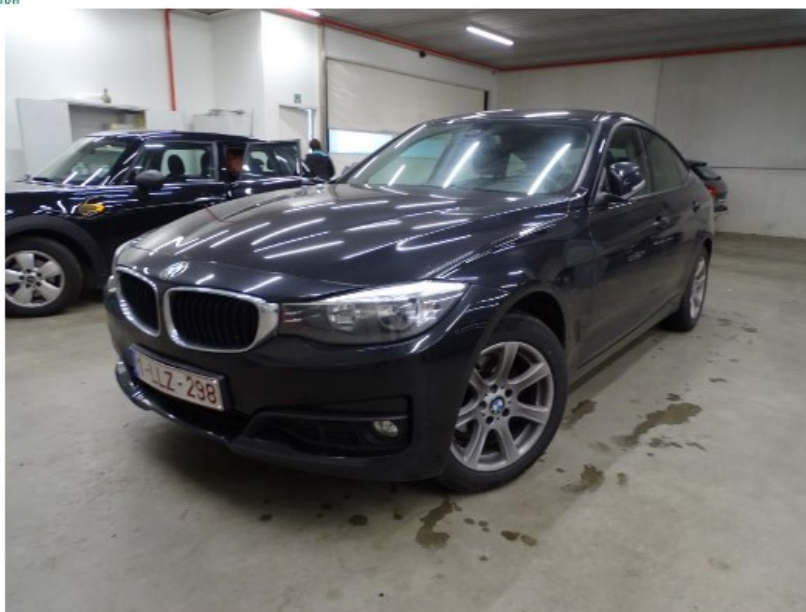
Total cost ex VAT	651,00
Wing R R, Scratch(es), Acceptable	0,00
No pictures to display	
Tailgate, Scratch(es), Acceptable	0,00
No pictures to display	
Bumper R, Hole, Le - Replace and paint	651,00
