## VOLVO V40: 1LKL942

Vinnumber:	<b>VV1MV74L1G2303530</b>	Versionname:	<b>2.0 D2 KINETIC</b>
First Registrationdate:	<b>13/10/2015</b>	Fiscalpower:	
Expertise Mileage:	<b>143941</b>	Power Kw:	<b>88</b>
Bodytype:		Body color:	<b>Light Blue</b>
Gearbox:	<b>MAN 6 VIT</b>	Paint type:	<b>Metalic</b>
Transmission:	<b>Front</b>	Rims summer:	<b>Aluminium</b>
Fueltype:	<b>Diesel</b>	Oil level:	<b>OK</b>
Battery functioning:	<b>Yes</b>	Parking lot:	<b>3404</b>
Number of doors:	<b>5</b>		
Number of seats:	<b>5</b>		
Number head rests:	<b>5</b>		
Rims summer:	<b>Aluminium</b>		
Category:	<b>Passenger Car</b>		
Oil level:	<b>OK</b>		
Registration Certificate Car (BE):	<b>Yes</b>

## Limited Technical Inspection

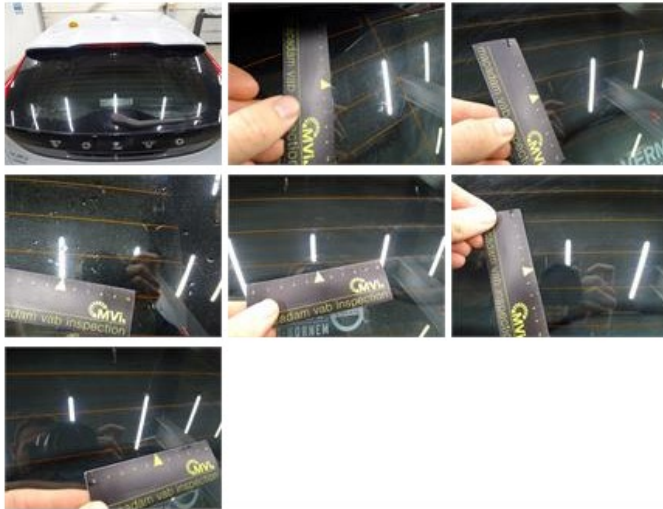
Door F R, Scratch(es), Acceptable	0,00
<i>No pictures to display</i>	
Alloy rim F R, Scratch(es), Acceptable	0,00
<i>No pictures to display</i>	
Door F L, Scratch(es), Acceptable	0,00
<i>No pictures to display</i>	
Rear window, Scratch(es), E - Replace	370,00

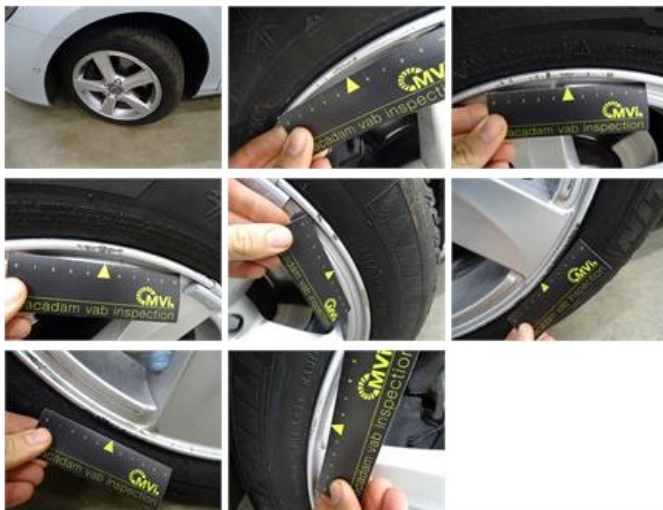
Alloy rim F L, Scratch(es), LI - Repair and paint (complete)	95,00
--------------------------------------------------------------	-------

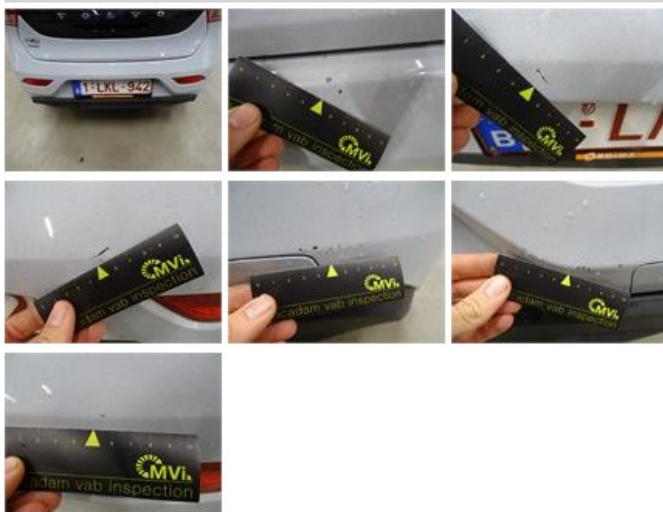
Bumper R, Scratch(es), LI - Repair and paint (complete)	211,80
---------------------------------------------------------	--------
