BMW 3: 1HKD041

Limited Technical Inspection

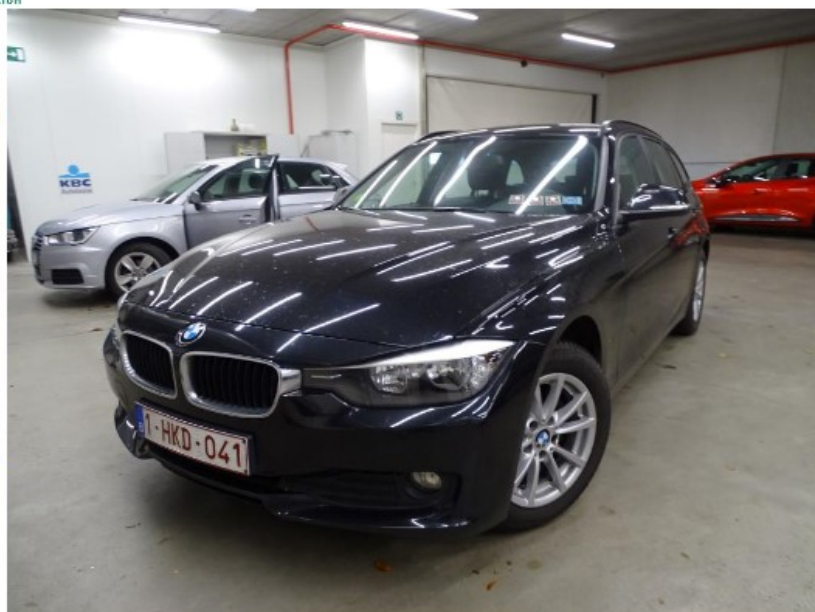
Vinnumber:	WBA3K11070F834322	Versionname:	3 TOURING 318d 136PK
First Registrationdate:	7/08/2014	Fiscalpower:	
Expertise Mileage:	93266	Power Kw:	100
Bodytype:		Body color:	Black
Gearbox:	MAN 6 VIT	Paint type:	Metalic
Transmission:	Back	Rims summer:	Aluminium
Fueltype:	Diesel	Oil level:	OK
Maintenance:	OK	Parking lot:	2601
Battery functioning:	Yes		
Number of doors:	5		
Number of seats:	5		
Number head rests:	5		
Rims summer:	Aluminium		
Category:	Passenger Car		
Oil level:	OK		
Registration Certificate Car (BE):	Yes
