AUDI A4: 1JEY634

Limited Technical Inspection

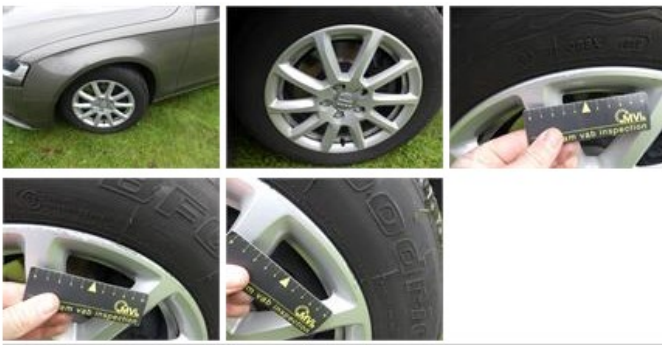
Emergency spare wheel	Yes	Jack	Yes
Total cost ex VAT			190,00
Seat cover R L, Stain, Acceptable			0,00
<i>No pictures to display</i>			
Alloy rim F L, Scratch(es), LI - Repair and paint (complete)			95,00

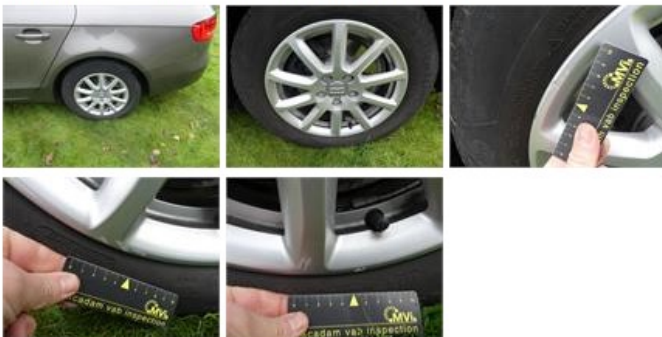
Door F L, Scratch(es), Acceptable	0,00
<i>No pictures to display</i>	
Door R R, Scratch(es), Acceptable	0,00
<i>No pictures to display</i>	
Alloy rim R L, Scratch(es), LI - Repair and paint (complete)	95,00
