BMW 2 Active Tourer: 1JEX404

Vinnumber:	WBA2C11030VZ55542	Versionname:	2 ACTIVE TOURER 218d 136PK
First Registrationdate:	28/11/2014	Fiscalpower:	
Expertise Mileage:	141101	Power Kw:	100
Bodytype:		Body color:	Blue
Gearbox:	MAN 6 VIT	Paint type:	Metalic
Transmission:	Back	Rims summer:	Aluminium
Fueltype:	Diesel	Oil level:	OK
Maintenance:	OK	Parking lot:	3401
Battery functioning:	Yes		
Number of doors:	5		
Number of seats:	5		
Number head rests:	5		
Rims summer:	Aluminium		
Category:	Passenger Car		
Oil level:	OK		
Registration Certificate Car (BE):	Yes

Limited Technical Inspection

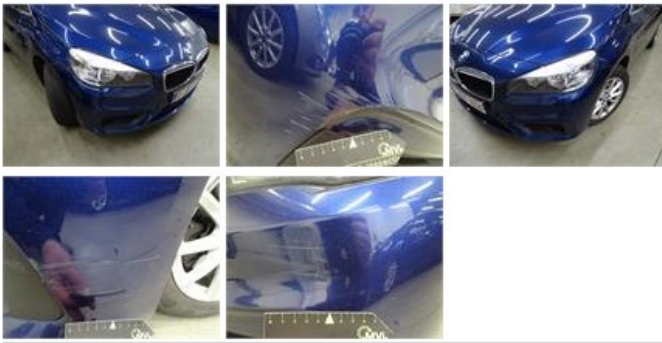
Repair kit	Yes	Compressor	Yes
Total cost ex VAT			536,60
Bumper F, Scratch(es), LI - Repair and paint (complete)			211,80
