**AUDI A4 AVANT: 1KUY485**

**Limited Technical Inspection**

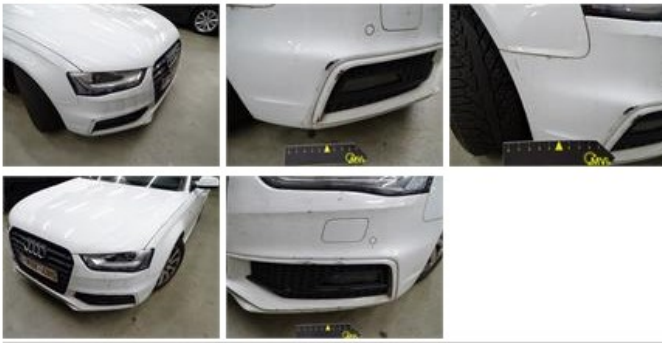
Bumper F, Scratch(es), LI - Repair and paint (complete)	211,80
---	--------

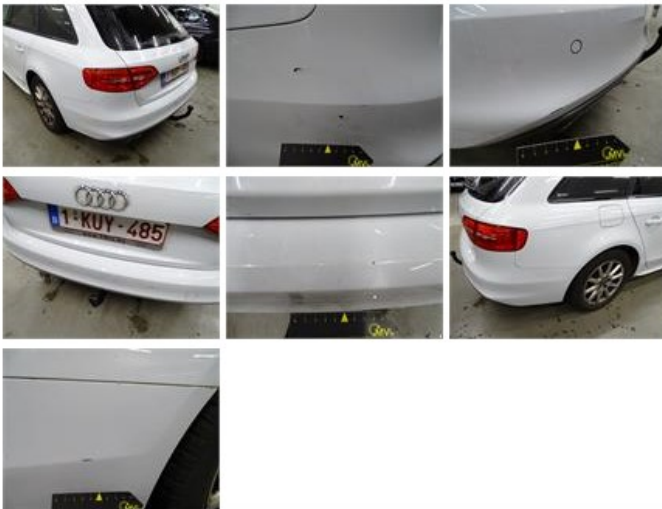
Tailgate, Scratch(es), Acceptable	0,00
<i>No pictures to display</i>	
Alloy rim R R, Scratch(es), Acceptable	0,00
<i>No pictures to display</i>	
Bumper R, Scratch(es), LI - Repair and paint (complete)	211,80
