BMW 5: 1JEX421

Limited Technical Inspection

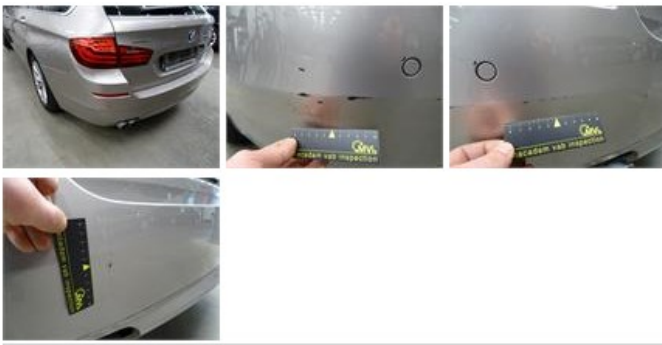
Total cost ex VAT	1210,96
Alloy rim F R, Scratch(es), Acceptable	0,00
<i>No pictures to display</i>	
Bumper R, Broken, Le - Replace and paint	766,80

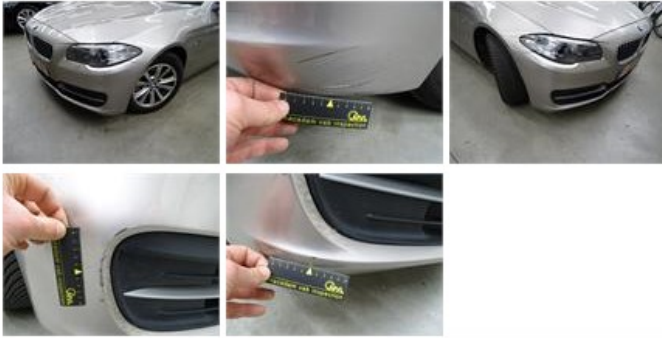
Bumper F, Scratch(es), LI - Repair and paint (complete) 254,16
