VOLKSWAGEN SHARAN: 1RCJ836

Limited Technical Inspection

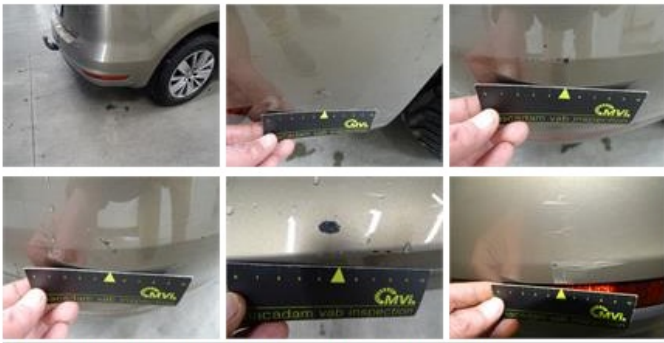
Total cost ex VAT	985,97
Bonnet, Chemical polution, Acceptable	0,00
<i>No pictures to display</i>	
Roof, Chemical polution, Acceptable	0,00
<i>No pictures to display</i>	
Bumper F, Scratch(es), Acceptable	0,00
<i>No pictures to display</i>	
Bumper R, Scratch(es), LI - Repair and paint (complete)	254,16
