VOLKSWAGEN Golf: 1JUC304

Limited Technical Inspection

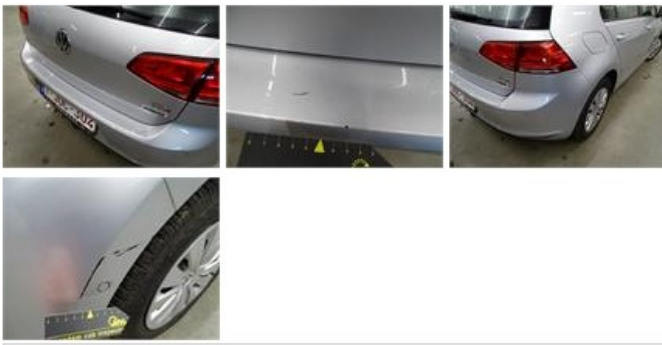
Total cost ex VAT	814,56
Bumper F, Scratch(es), Acceptable	0,00
<i>No pictures to display</i>	
Bumper R, Scratch(es), LI - Repair and paint (complete)	211,80

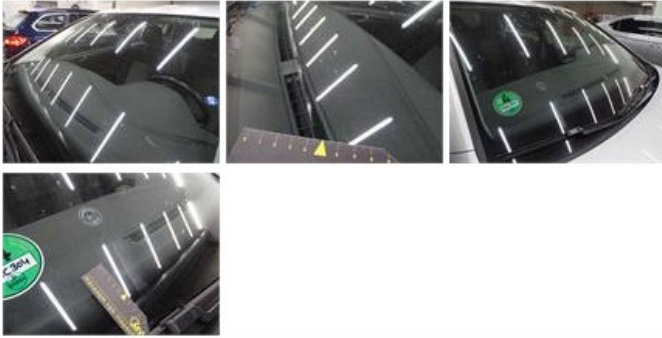
Windscreen, Scratch(es), E - Replace 487,20
