AUDI Q3: 1LET145

Limited Technical Inspection

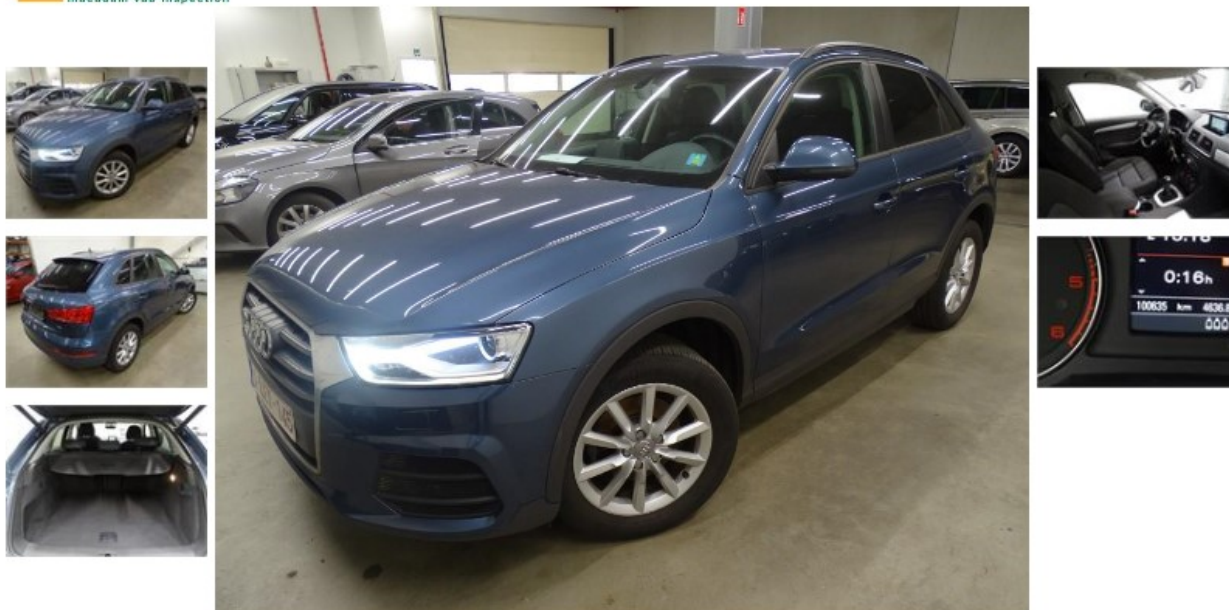
Vinnumber:	WAUZZZ8U3GR030802	Versionname:	2.0 TDI 110KW
First Registrationdate:	8/09/2015	Fiscalpower:	
Expertise Mileage:	100635	Power Kw:	110
Bodytype:		Body color:	Blue
Gearbox:	MAN 6 VIT	Paint type:	Metallic
Transmission:	Front	Rims summer:	Aluminium
Fueltype:	Diesel	Oil level:	OK
Battery functioning:	Yes	Parking lot:	1527
Number of doors:	5		
Number of seats:	5		
Number head rests:	5		
Rims summer:	Aluminium		
Category:	Passenger Car		
Oil level:	OK		
Registration Certificate Car (BE):	Yes
