**BMW 3 BERLINE: 1JLU288**

**Limited Technical Inspection**

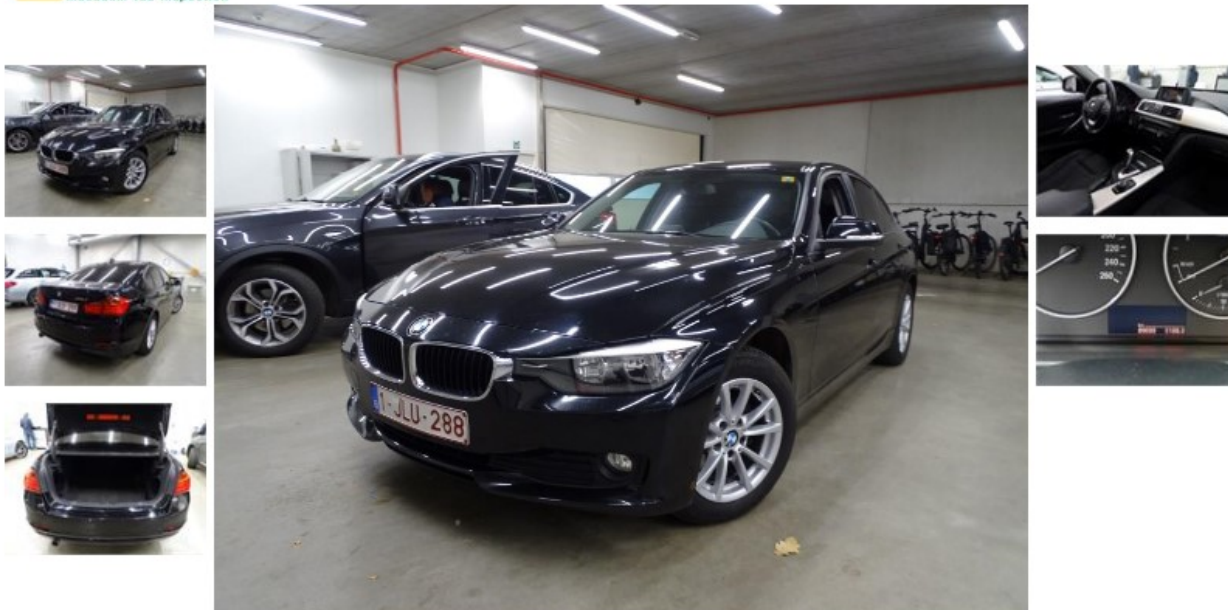
Repair kit	<b>Yes</b>	Compressor	<b>Yes</b>
Total cost ex VAT			<b>423,60</b>
Wing R R, Bad repair, LI - Repair and paint (complete)			<b>0,00</b>
