AUDI A4 AVANT: FP9935

Vinnumber:	WAUZZF43GA034964	Versionname:	2.0 TDI 110KW
First Registrationdate:	15/02/2016	Fiscalpower:	
Expertise Mileage:	60499	Power Kw:	110
Bodytype:		Body color:	Black
Gearbox:	MAN 6 VIT	Paint type:	Metalic
Transmission:	Front	Rims summer:	Aluminium
Fueltype:	Diesel	Oil level:	OK
Battery functioning:	Yes	Parking lot:	4202
Number of doors:	5		
Number of seats:	5		
Number head rests:	5		
Rims summer:	Aluminium		
Category:	Passenger Car		
Oil level:	OK		
Registration Certificate Car (BE):	Yes

Limited Technical Inspection

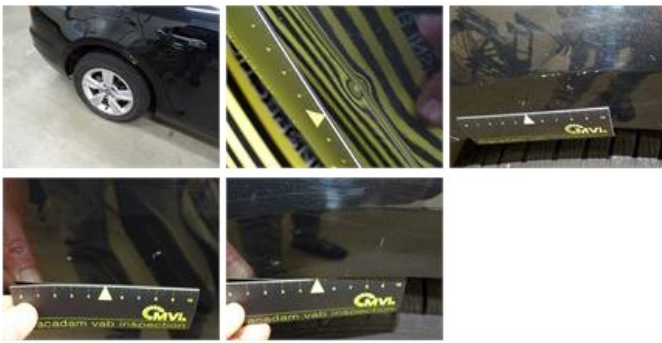
Total cost ex VAT	520,00
Rearview mirror housing R, Scratch(es), Acceptable	0,00
<i>No pictures to display</i>	
Wing R R, Dent(s) and scratch(es), LI - Repair and paint (complete)	308,20
