BMW X4: XX6709			
Vinnumber:	WBAXX110600T42113	Versionname:	2.0 XDRIVE20D (140KW) 4WD
First Registrationdate:	26/01/2017	Fiscalpower:	
Expertise Mileage:	68688	Power Kw:	140
Bodytype:		Body color:	Blue
Gearbox:	Automatic	Paint type:	Metalic
Transmission:	4 Weel	Rims summer:	Aluminium
Fueltype:	Diesel	Oil level:	OK
Battery functioning:	Yes	Parking lot:	3423
Number of doors:	5		
Number of seats:	5		
Number head rests:	5		
Rims summer:	Aluminium		
Category:	Passenger Car		
Oil level:	OK		
Registration Certificate Car (BE):	No

Limited Technical Inspection			
Airco functioning	OK	Battery functioning	Yes
Tires wear profile	OK	Power steering	Yes
Idle position	OK	Sound engine	OK
Engine startingtime	OK	Clutch test	NOT OK
Exhaust gass	OK	Wiper fluid level	OK
Handbrake	OK	Transmission	OK
		Lighting	OK
		Wiperblades	OK

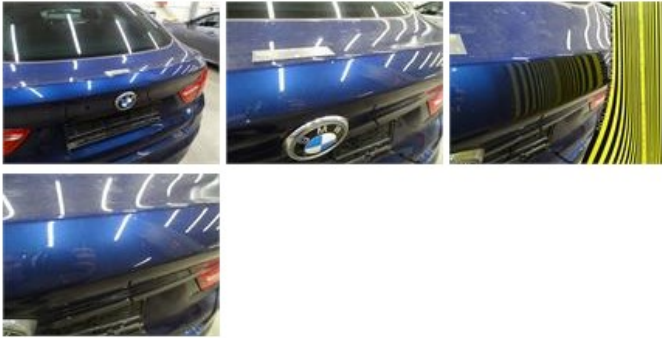
Alloy rim R R polished, Scratch(es), Acceptable	0,00
<i>No pictures to display</i>	
Bumper R, Scratch(es), Acceptable	0,00
<i>No pictures to display</i>	
Door F L, Scratch(es), Acceptable	0,00
<i>No pictures to display</i>	
Door R R, Scratch(es), Acceptable	0,00
<i>No pictures to display</i>	
Tailgate, Dent(s) and scratch(es), LI - Repair and paint (complete)	362,02
